17-12 Chapel Street, Bradford, Grade 2 listed
Selected Photos
Architectural Services Tender
June 2025

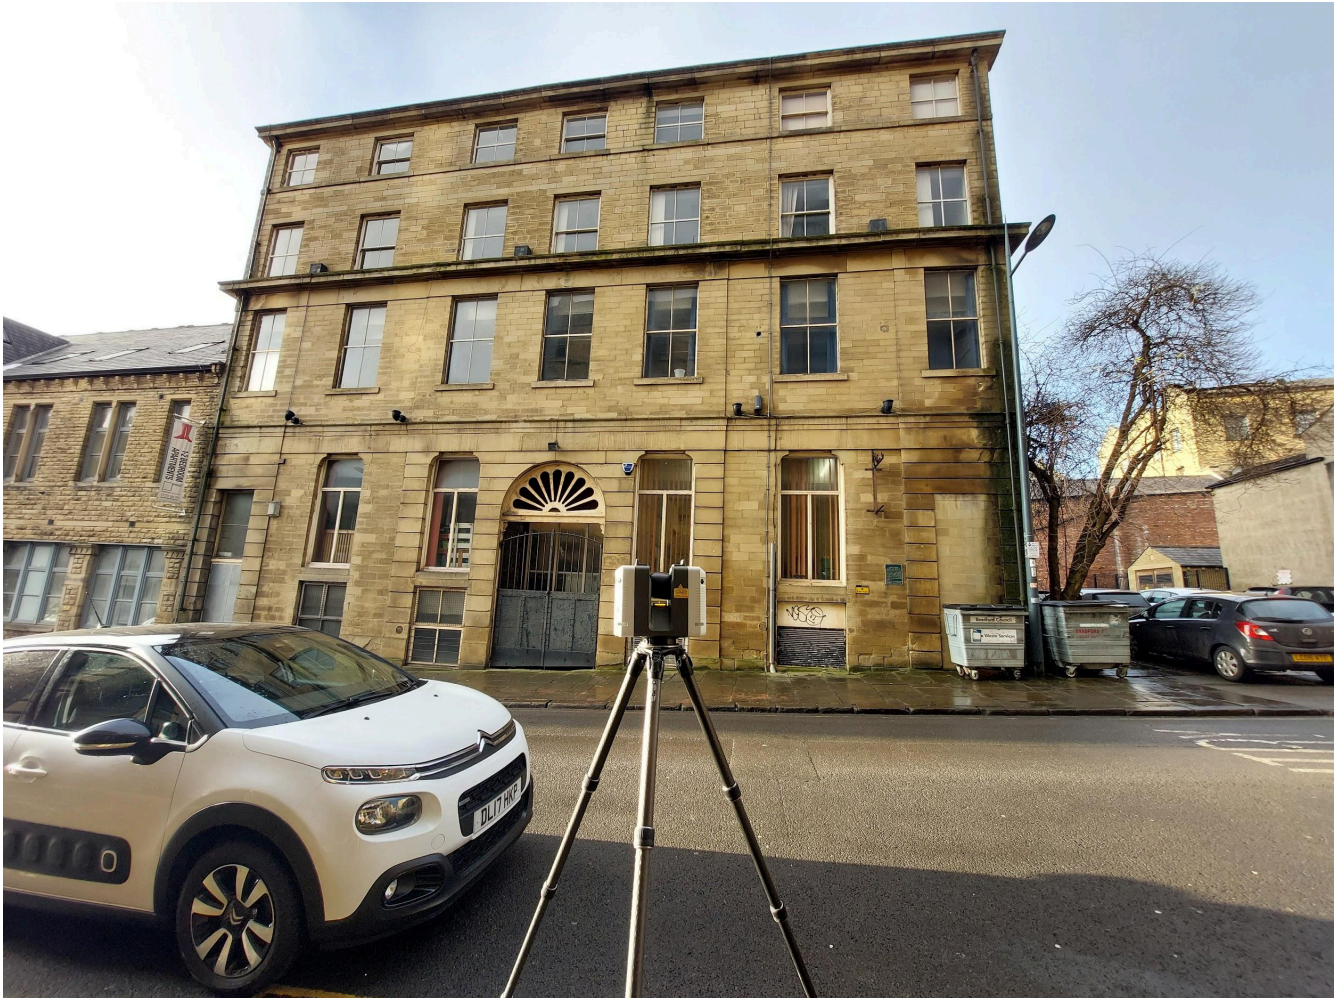
17-21 Chapel Street - East Facade, Chapel Street Elevation, January 2025. Double cast iron railed gates in the centre and a radial cast iron fanlight above. The majority of Ashlar stonework is in reasonable condition. See next photo for an example of work required though. The stonework areas behind the failed cast-iron rainwater goods need cleaning but are otherwise mostly sound.

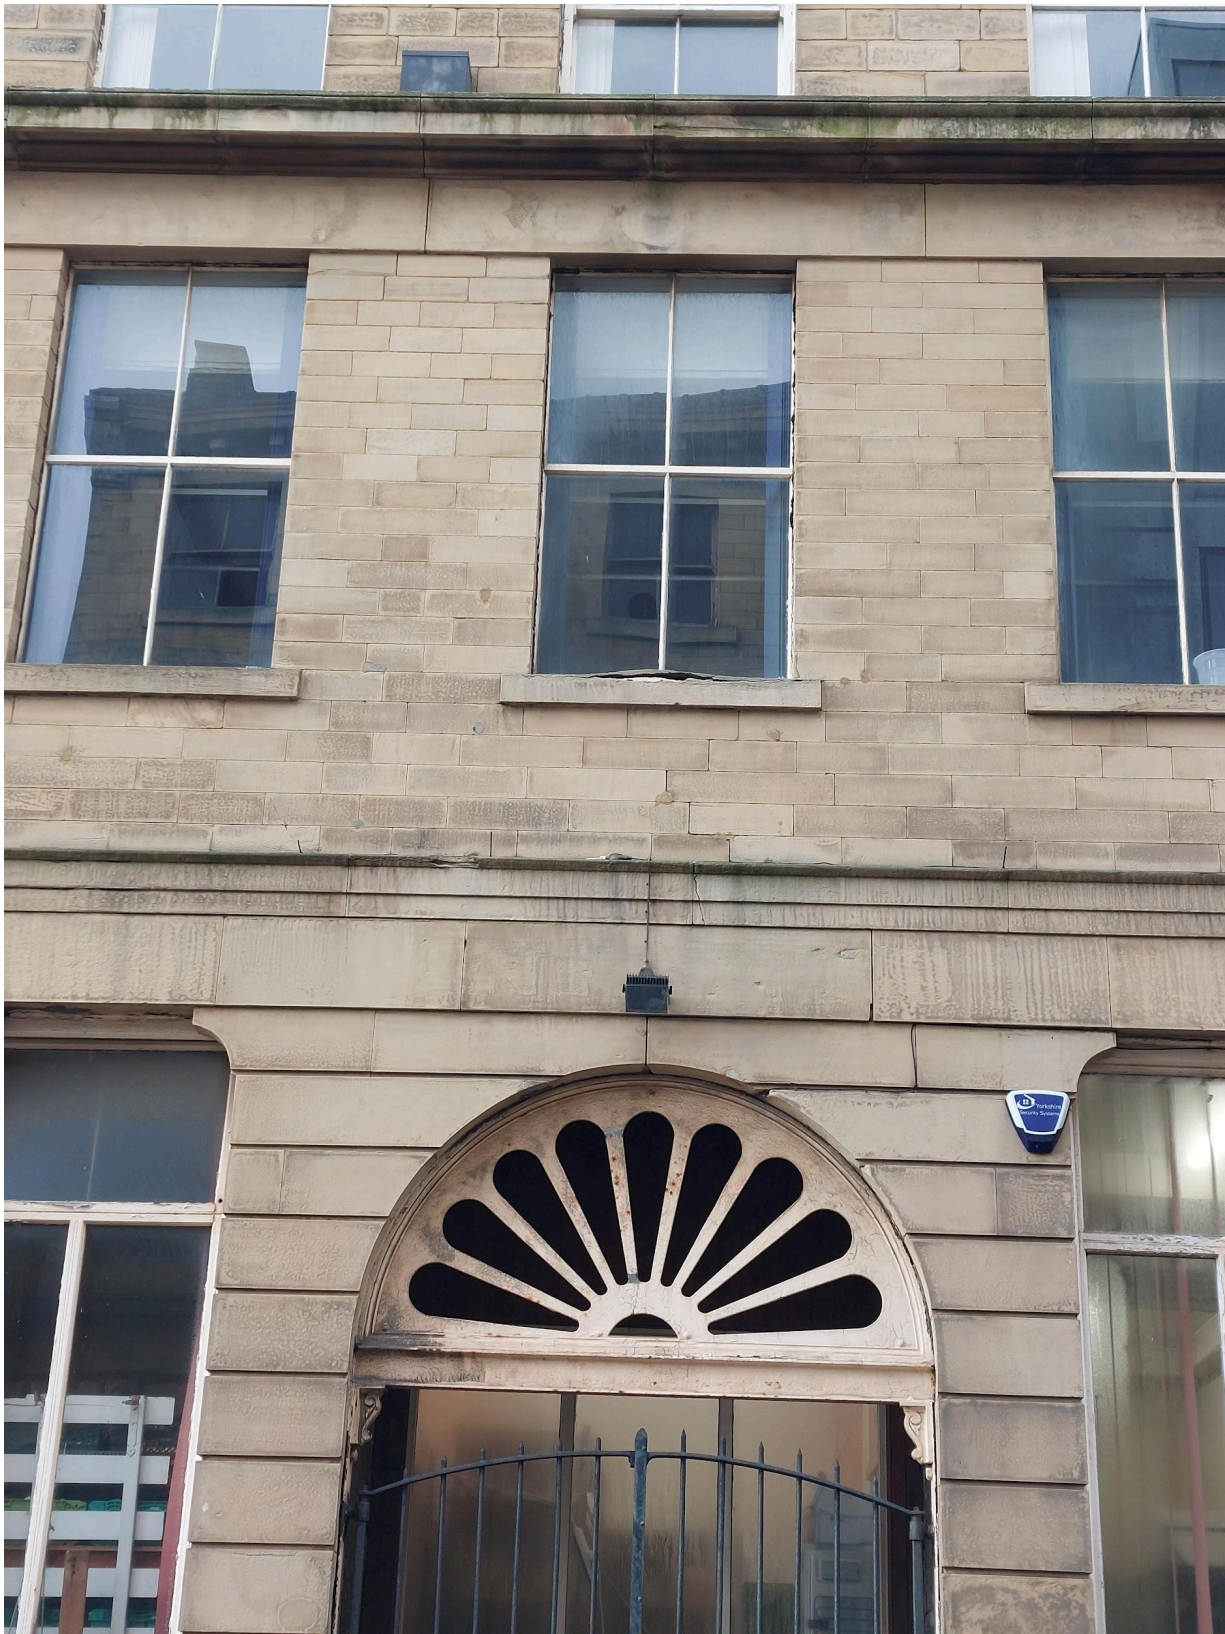
17-21 Chapel Street, East Elevation - Fan light and delaminating Ashlar Stone cill, window on floor above

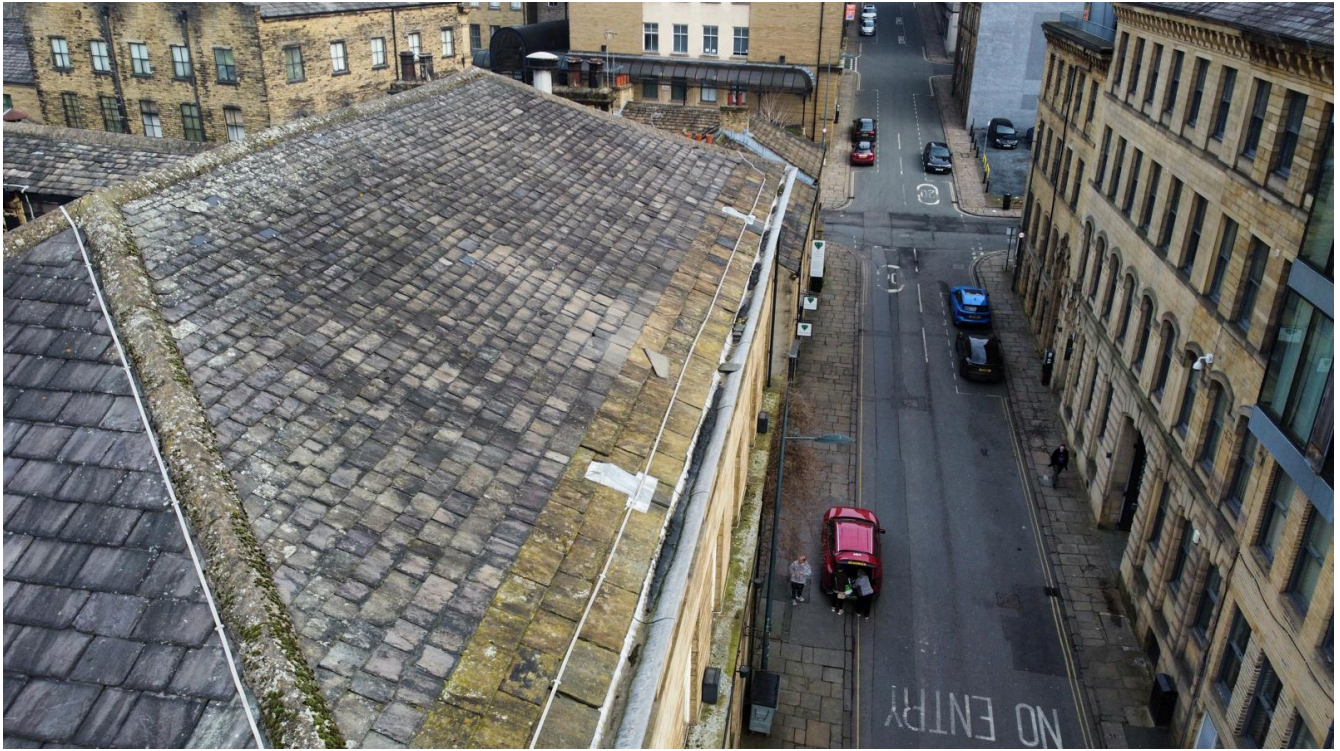
17-21 Chapel Street - Main Roof, (east) Chapel Street Elevation showing the lead-lined gutter, three courses of Westmorland Stone slates to eaves with traditionally laid diminishing courses of Welsh slate above.

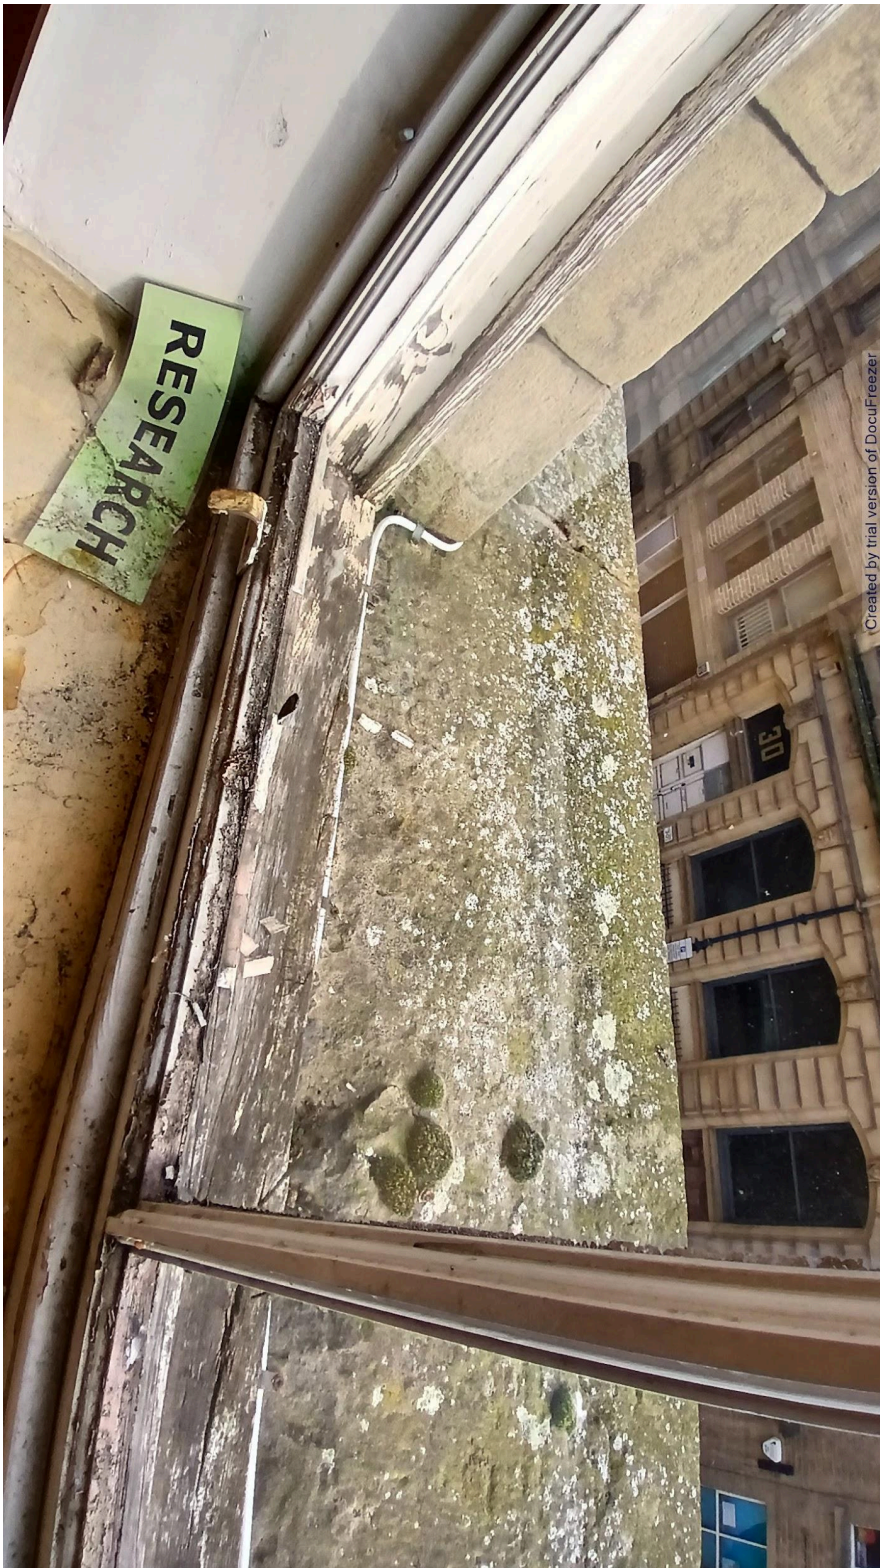
17-21 Chapel Street - Timber Decay in window, Chapel Street (East) Elevation

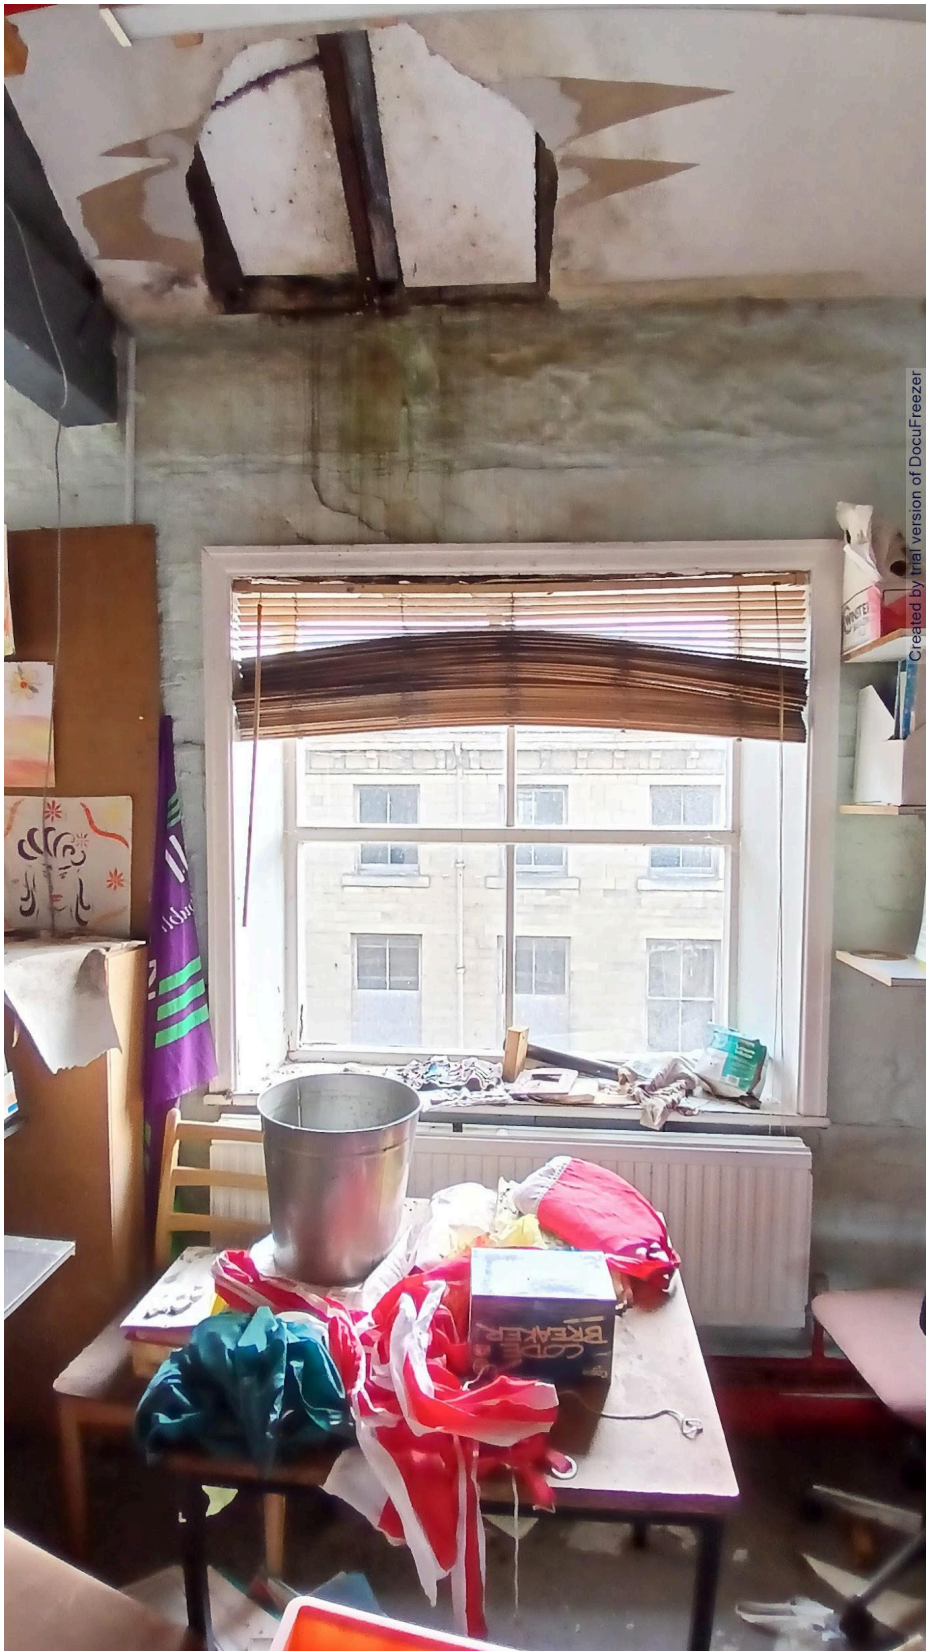
Water Ingress at Eaves - most likely caused by failure of the lead lined gutters directly above.
